Effects of change of use of land on an aquifer in a tectonically active region

ABSTRACT

Keywords: Land Use; Faults; GIS; Drawdown; Remote Sensing

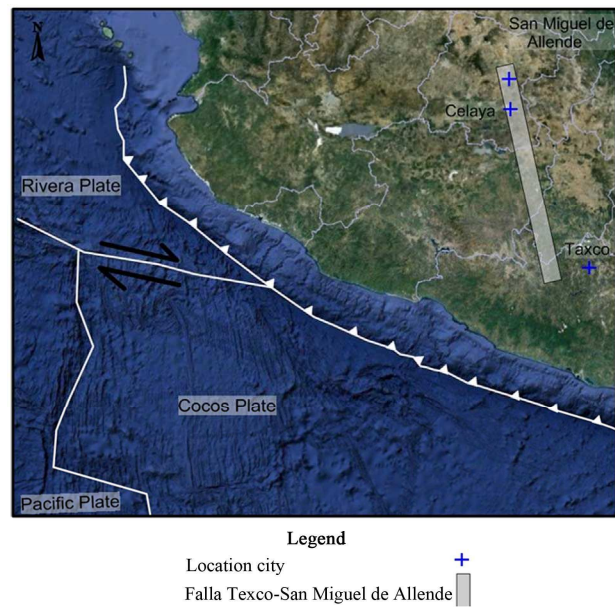
Figure 2. Taxco-San Miguel de Allende fault system.

The study area is located in the State of Guanajuato, in the central part of Mexico, lies within the physiographic Province called the Neovolcanic axis (**Figures 1 and 2**), that is characterized by a volcanic chain of plio-Quaternary Age volcanic chain which extends from the Ocean Pacific to the West of the country, to the Gulf of Mexico.

The structural geology of Celaya Valley lies within what is known as the Neovolcanic axis, reason why there are numerous faults in this area. The study area is affected by various systems of faulting, one belonging to the system Taxco-San Miguel de Allende orientation NNW-SSE [6], which passes through the center of Mexico, another fault with orientation system E-W is associated with the Transmexican Volcanic Belt. Normal type faults are reported in the study area (**Figure 3(b)**), similar to the system oriented Taxco-San Miguel.

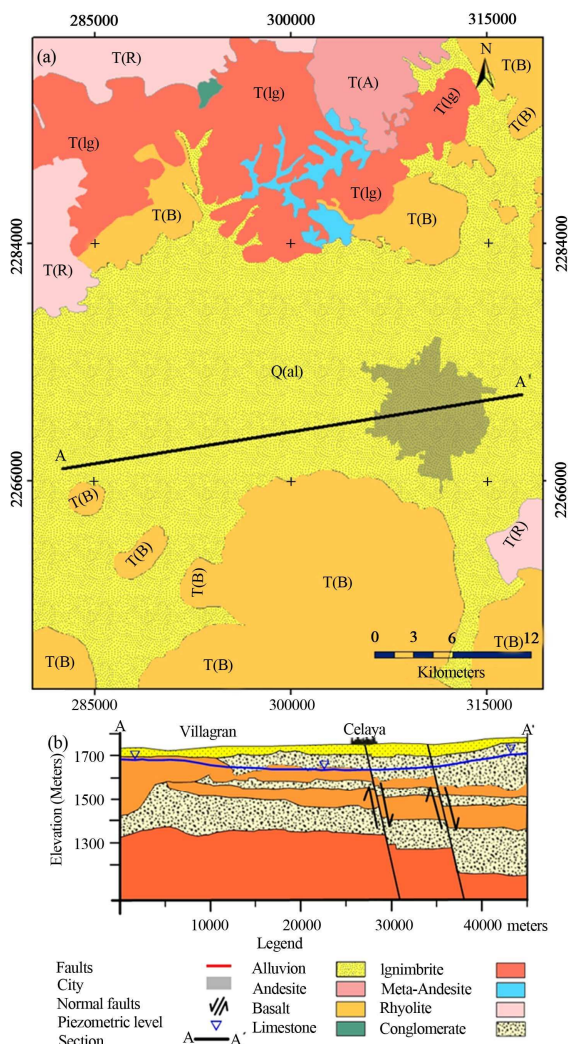
Figure 3. (a) Map shows the distribution of the different geological units in the Valley of Celaya, with rocks coming from the Cretaceous to Quaternary. (b) Geological section, which passes through the Valley of Celaya from East to West.

reaching thicknesses of 600 m. Since the Valley is of tectonic origin, collapsed, volcanic rocks are covered by continental deposits (sandstones and conglomerates) with a thickness of 300 m. The last volcanic activity (basalts) occurred during the Quaternary. Finally, Quaternary clayey deposits cover the Valley, reaching 150 m thick (**Figure 3**).

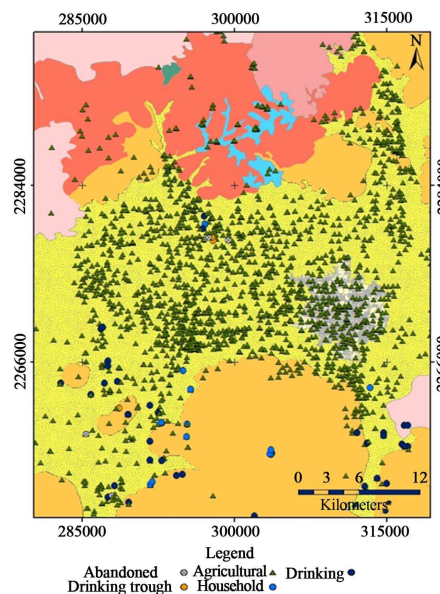
Figure 4. The density of wells increased to 1897 by the year of 1990.

With regard to the lifting of the static level, in the year of 1956, there were so many alterations to the aquifer and the number of wells did not exceed 100 (**Figure 4**). Agricultural activity and the development of the aquifer were located mainly in the central part of the Valley and another area where there was this same development was to the West of the city of Celaya. The extraction of groundwater in the Valley initiated the formation of a small drawdown elongated of orientation NW to SE. **Figure 5** shows to the northeast of the study area, high piezometric of 1760 meters above sea level (MASL), indicating an important recharge area (**Figure 5(a)**).

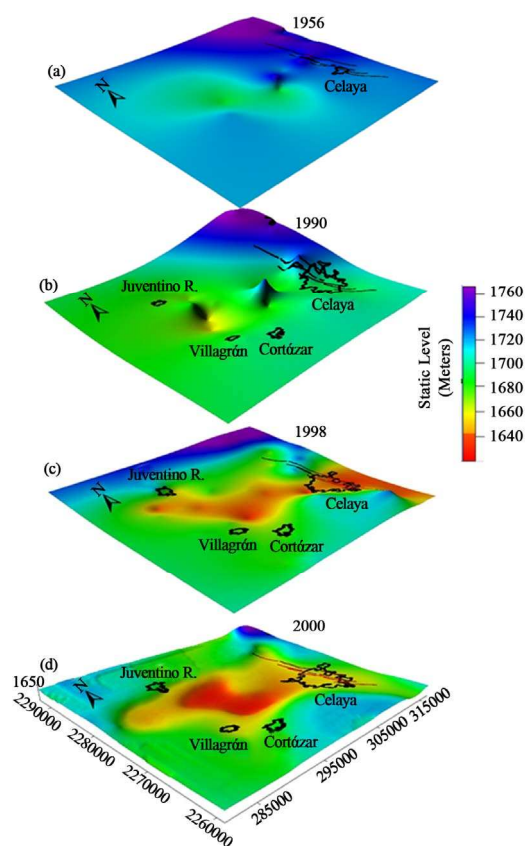
Figure 5. Distribution of piezometry by the end of the 50's. (a) recharge zones occur where the elevation of the static level is high; (b) panorama of 1990 where the drawdown reaches the city of Celaya; (c) in 1998 drawdown has more definition in the Valley; and (d) in 2000 the drawdown shows recovery in Celaya and significant decreases in Villagrán.

Valley of Celaya. The piezometry shows a greater extension of the drawdown that reaches the city of Celaya (**Figure 5(b)**), with a low piezometric level (1678.45 MASL) and in addition, a general decrease of the Valley piezometric levels.

With an increase in a period of eight years, the number of wells increased to 2162 on the year 1998, the drawdown defined towards the center of the Valley, taking an elongated form with directions NW-SE which passes through the city of Celaya (**Figure 5(c)**).

In the 2000 census, the number of wells had no significant variations and the drawdown displayed a recovery of its levels towards Celaya; however, towards Villagrán, the drawdown had significant declines (**Figure 5(d)**).

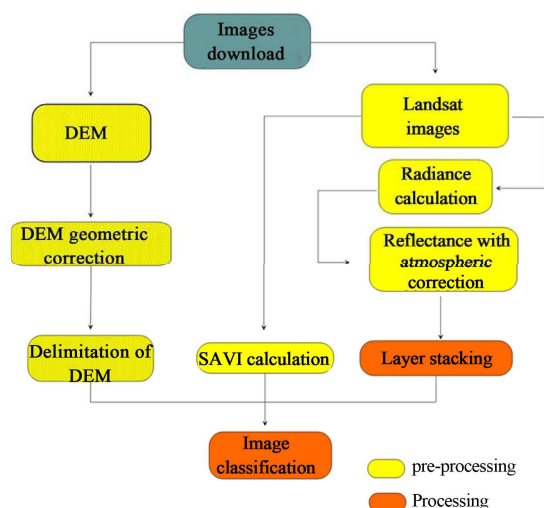
Figure 6. Methodology applied to the treatment of the Landsat MSS, Landsat TM images.

The methodology developed in this work consists of pre-processing stage and the stage of processing (**Figure 6**). The first stage is to apply correction techniques to satellite images to later extract information based on spectral or textural characteristics of the different surfaces of the land. The main processes that are conducted at this stage are; geometric correction of the original bands of the Landsat images, with the purpose of obtaining a good overlap between the data obtained from Landsat MSS, Landsat TM and DEM images. In addition for each satellite image was performed radiance calculation

Several techniques for data extraction were applied in the processing stage, among them are the analysis of spectral signatures to identify the different coverages of soil and vegetation Soil-Adjusted Vegetation index (SAVI) to separate different types of vegetation based on the presence of chlorophyll and humidity which are related to the vigour of the vegetation [11]. The results of these operations were used as input data for the classification made on each satellite image (Figure 6).

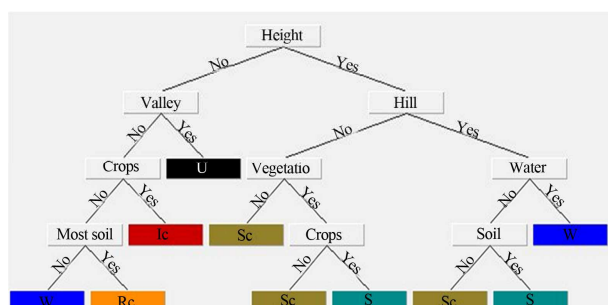
Figure 7. Methodology ID3 applied as a technique of classification of the Landsat MSS, Landsat TM images. The nomenclature used was b1 = DEM, b2 = Band 1 used to highlight the urban zone, b3 = 4 Band used to highlight water bodies, gt = Greater tan, lt = Less tan. The figures (quantities) that accompany the parameters are the values constraints.

The classification of satellite images was performed using the technique of the decision tree also known as "Induction using decision trees" ID3. The basic idea of the ID3 is to determine for a set of data, the most important attribute, *i.e.* that which has the greatest discriminating power for a set. This first attribute is associated with the values of the set and it is used to perform an initial partition in the classification. After the first test attribute, this threw a result, which is in itself a new learning problem of the decision tree, with the difference that it will have fewer elements and one attribute less, thus, each attribute that is selected is discarded for the next test. The way in which develops the ID3 classification is by the principle of binomial math (Figure 7). For the classification were assigned six classes according to the characteristics of each scene and taking into account the nomenclature of the Instituto Nacional de Estadística y Geografía (INEGI). These six classes are: Water bodies (w), Scrub (Sc), Irrigated crop (Ic), Rain feed crop (Rc), Soil without vegetation (S) and Urban (U).

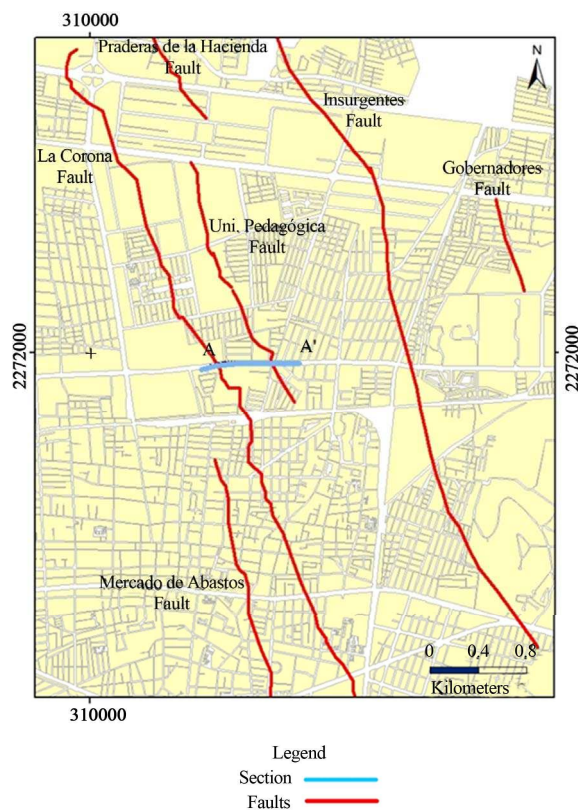
Figure 8. The image shows the location of the topographical sections (purple line) within the city.

Field work focused primarily on the topographic surveys within the city of Celaya. The direction taken for the uprising was East-West that is almost perpendicular to the train of failure of orientation NNW-SSE of Taxco-San Miguel de Allende fault system. Part of the information collected during the uprising was the measurement of differential movement within the city and the vertical displacement. The stroke of the sections took place east of the city on faults that cross this part, South section was drawn on the Mercado de Abastos failures and La Corona, and North sections were on La Corona fault and the fault Universidad Pedagógica (Figure 8).

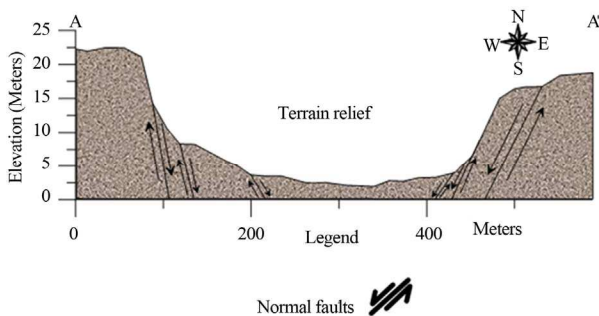
Figure 9. Topographic survey on Irrigation street, showing a graben.

The topographical section (A - A') has a length of 580.5 m. This section cuts two faults, La Corona fault which has the roof dropped Eastward and the Universidad Pedagógica fault with fallen roof to the West, this series of faults form a graben, (Figure 9). The measured

dislocation of La Corona fault is of 2.26 m and the approach in the University fault is 2.06 m above the profile different failures can be appreciated which is the result of the formation of the graben.

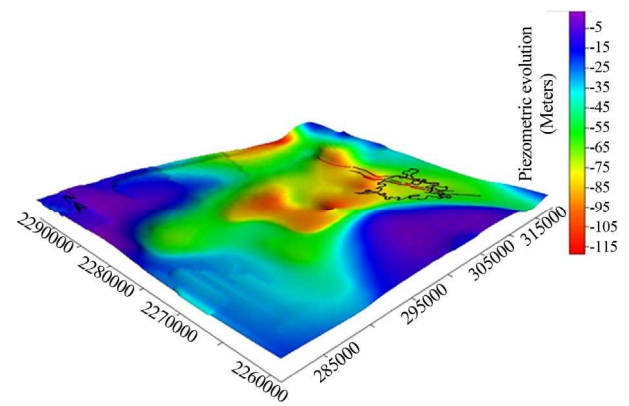
Figure 10. Image showing the evolution in the elevation of the static level within the study area.

Figure 10 shows the evolution of the static level for aquifer of Celaya. This figure shows in blue the shallowest parts. These areas have a depth that varies from 0 to -25 m and correspond to the mountains surrounding the Valley of Celaya. The color cyan to green light zone has a range of values of -35 to -55 mm. This zone corresponds to the margin close to the mountains. Yellow to orange area has a range of -65 to -75 m. This area is related to the Valley. The area ranging from orange to red is the deepest, and it has values from -85 to -115 m, and corresponds to the deepest part of the drawdown.

In the Western portion of the city of Celaya is where the most significant values of evolution are found, this area has values ranging from -75 to -85 m. The areas near the train of fault within the city of Celaya have a minor evolution with depth values that range from -65 to -75 m, compared to the Northern zone, where also passes the train's fault but presents values of -75 - 95 mm.

The greatest evolution over the Valley occurs towards the municipality of Villagran where values are recorded ranging from -55 m - 65 m, while towards the municipalities of Juventino Rosas and Cortazar signify cant values of depth are not observed.

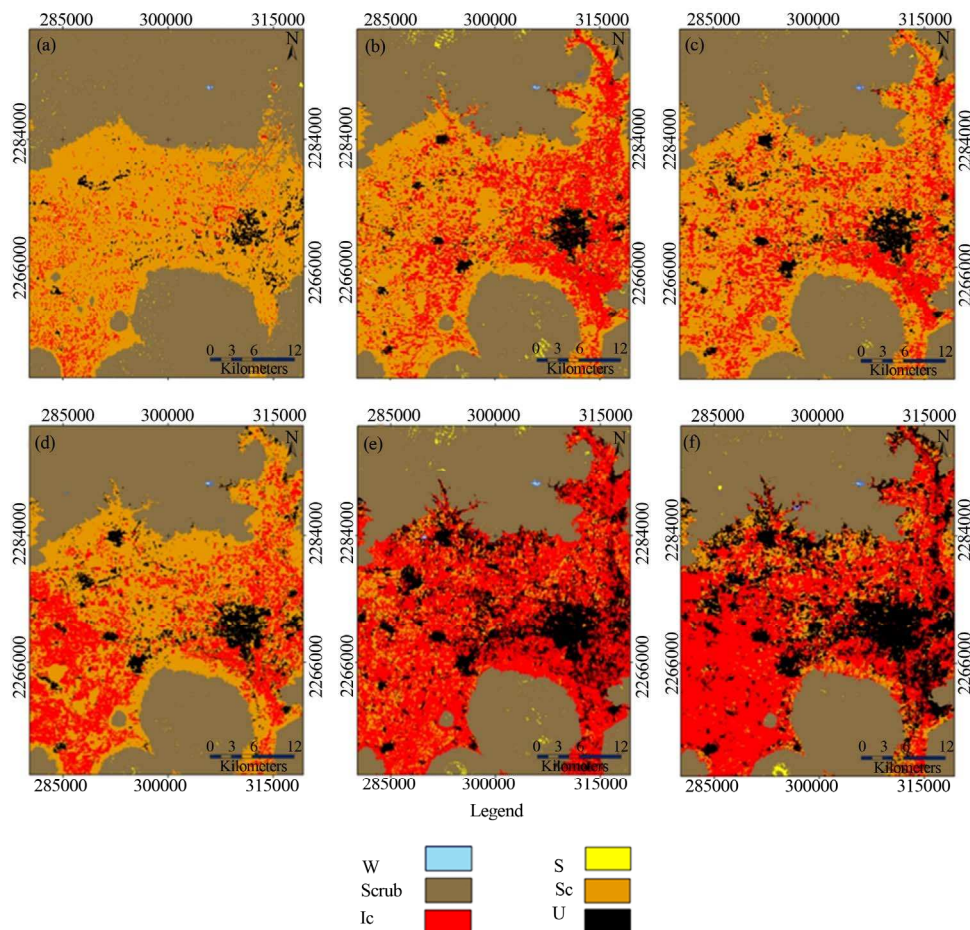
Figure 11. Land use maps for (a) 1976; (b) 1989; (c) 1999; (d) 2000; (e) 2009; and (f) 2011. The classes obtained are: water bodies (W), Scrub (Sc), Irrigated crops (Ic), rain fed crops (Rc), soil without vegetation (S) and urban (U). Orange color corresponds to Rc and red color shows Ic.

Land use for 1976. This year it is the initial stage of the analysis of the evolution of change in land use in the study area. The resulting map of the classification of the Landsat MSS of 1976 image shows that the main activity was the seasonal agriculture. For this year the distribution of surface between classes is: S (41.14 km²), Rc (918.83 km²), Sc (991.27 km²), U (19.35 km²), Ic (35.89 km²) and W (0.32 km²). Therefore, for 1976, the 45.8% of the surface was occupied by rain fed crops and only 1.8% corresponded to irrigated crops (**Figure 11(a)**).

Land use for 1989. By 1986, the agricultural activity had a significant change (**Figure 11(b)**). Class S fell to

36.09 km², class Ic increased to 103.94 km², class Sc decreased its area to 746.66 km², class U increased its surface at 35.72 km², class Rc had a significant growth in the East of the study area, reaching a surface of 1083.94 km² and the W class presented an increase on its surface to 0.45 km². In this year, it is already possible to identify the municipalities of Juventino Rosas, Villagran and Cortazar due to its surface growth.

Land use for 1999. In 1999 the Ic class was which showed the greatest increase, occupying an area of 196.35 km². By this period there is also a loss of area in the Rc class which its surface is of 986.96, km². The class U increased to 40.01 km² and class S had a notable loss being an area of 24.64 km². The changes of area in other classes were not relevant to remain almost with the same surface (**Figure 11(c)**).

Land use for 2000. With just one year elapsed the classification of land use for the year 2000 (**Figure 11(d)**), showed variations in the S-class which was reduced to an area of 11.88 km², class Rc presents a decrease of surface to 948.26 km². On the other hand, there

Land use for 2009. The situation changed drastically in the classification of land use in 2009 (**Figure 11(e)**), the S class increased its area to 29.9 km². Continuing with the same trend from past periods, the Rc class reduced its surface to 409.66 km². The class U presents its greatest increase in surface reaching 179.85 km². Class Ic also increased its surface at 633.27 km². The W class increased its surface of 1.11 km², this increase can be explained due to the appearance of some troughs near the municipality of Juventino Rosas. For the land use map of this year Ic occupied for the first time more area than the Rc class, which prevailed years ago.

Land use for 2011. Finally the classification for the year 2011 was conducted, (**Figure 11(f)**), in order to display the most recent status of the distribution of land use in the region. S class has an area of 23.3 km². The Rc class presents an area of 413.34 km². The Sc class dis-

plays a surface of 659.75 km², class U occupies an area of 213.32 km². Class Ic is the one which dominates the entire Valley occupying an area of 696.28 km², class W had a loss for the last year reduced to an area of 0.81 km². The comparison established between the extreme dates 1976 and 2001, shows significant losses of surface for classes S, Rc and Sc and important increases for CI classes, U and W.

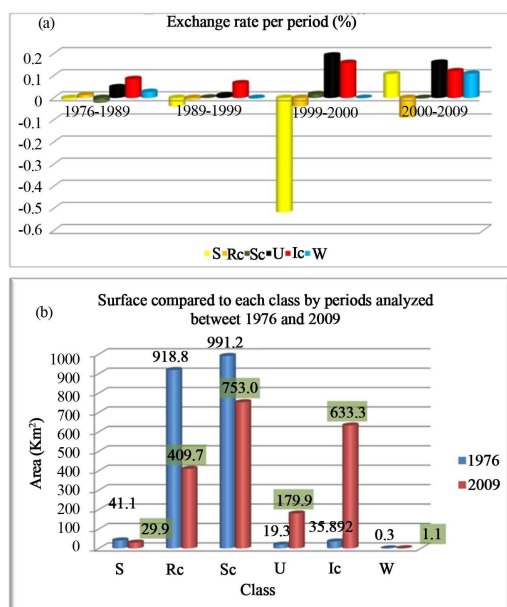
Figure 12. Graphic showing the rate of change of land covers for (a) all periods considered in this study, (b) for 1976-2019 period. Classes: Water bodies (W), Scrub (Sc), Irrigated crops (Ic), Rain fed crops (Rc), Soil without vegetation (S) and Urban (U).

The rate of change was made in order to quantify the losses or increases of different coverages of the region. In **Table 2**, negative values indicate loss of area and positive values indicate increase in the surface between the analyzed dates. These results, in turn, can be represented in a comparison chart (**Figure 12**) to display the change rate into a single image.
